# Tornado Outbreak November 17, 2013

A major severe weather outbreak unfolded on Sunday as numerous tornadoes were spawned from supercell thunderstorms that formed in an unstable and highly sheared atmosphere. Provided below are results of several damage surveys conducted by the National Weather Service in Paducah over the past few days. Additional damage assessments are scheduled to take place in Scott County of southeast Missouri today.

**...DAMAGE SURVEY RESULTS FOR MCCRACKEN, MASSAC, POPE, LIVINGSTON, AND LYON COUNTIES...**

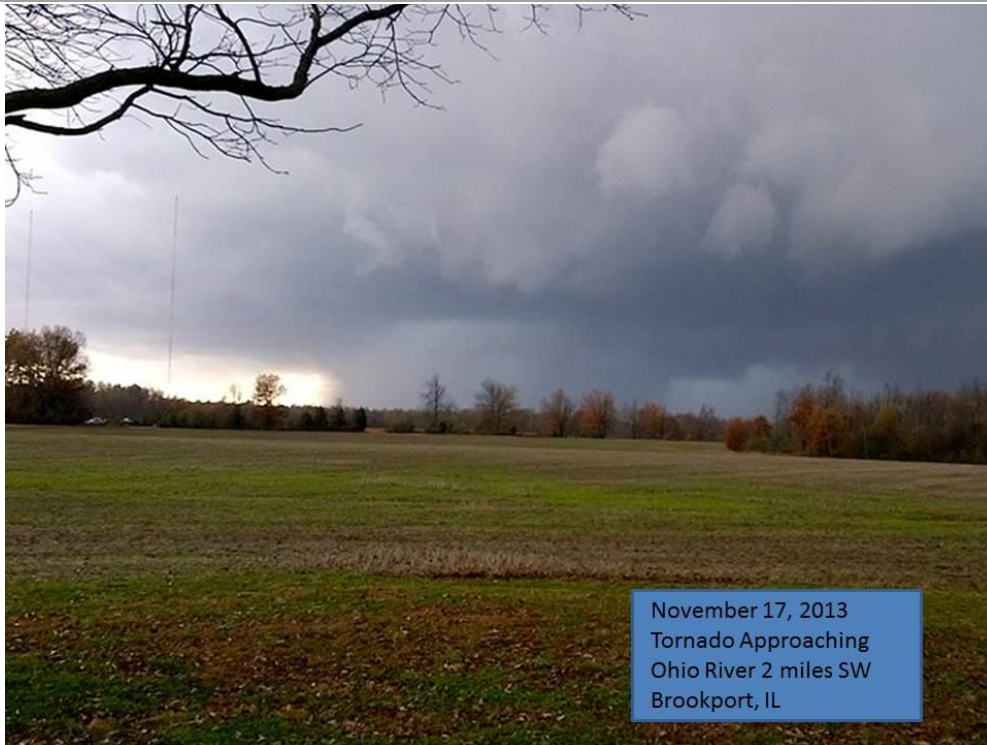
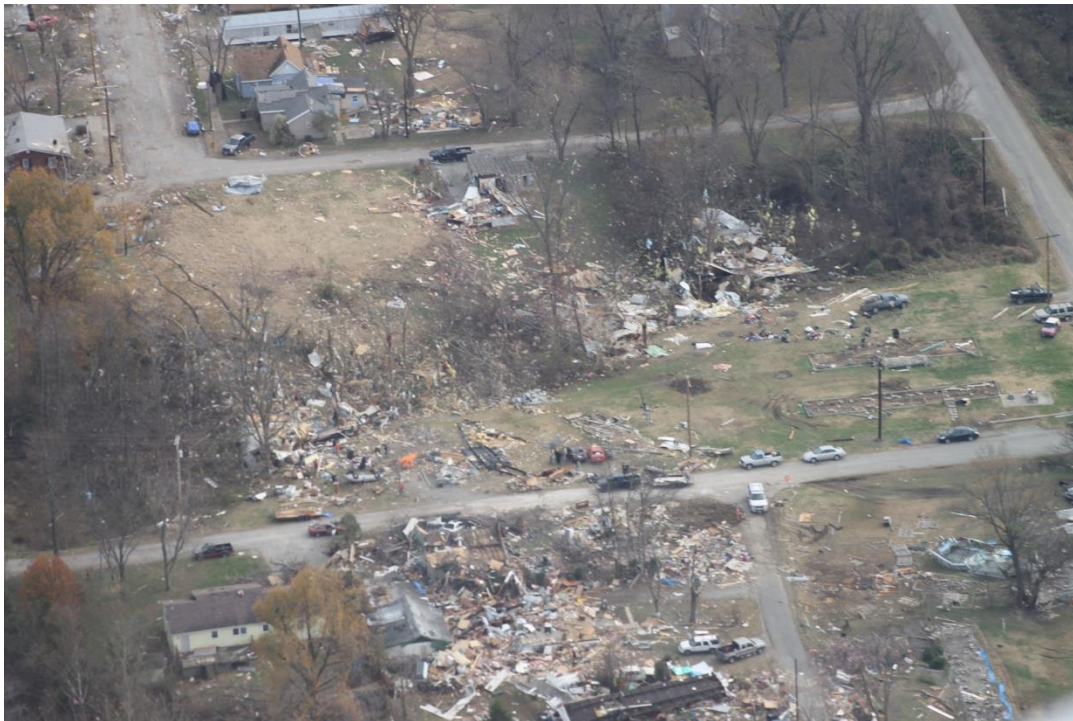
Damage in Brookport, IL from Brookport Tornado.

IN MASSAC COUNTY: DOZENS OF MOBILE HOMES DESTROYED, MANY BLOWN 100 FEET OR MORE. ONE HOME LEVELLED WITH DOZENS OF HOMES, GARAGES, STORAGE BUILDINGS, BUSINESSES AND OTHER BUILDINGS STRUCTURALLY DAMAGED. SEVERAL CARS AND A SCHOOL BUS TOSSED AROUND. AT LEAST HUNDREDS OF TREES SNAPPED AND UPROOTED. DAMAGE WAS IN BROOKPORT AND ALONG AND NORTH OF UNIONVILLE ROAD TO THE OHIO RIVER SOUTHWEST OF HAMLETSBURG, AND RATED EF-3.
