A Recommendation for an
ENHANCED FUJITA SCALE
(EF-Scale)

Submitted to
The National Weather Service
and
Other Interested Users

June 2004

WIND SCIENCE AND ENGINEERING CENTER
Texas Tech University
Lubbock, Texas 79409-1023

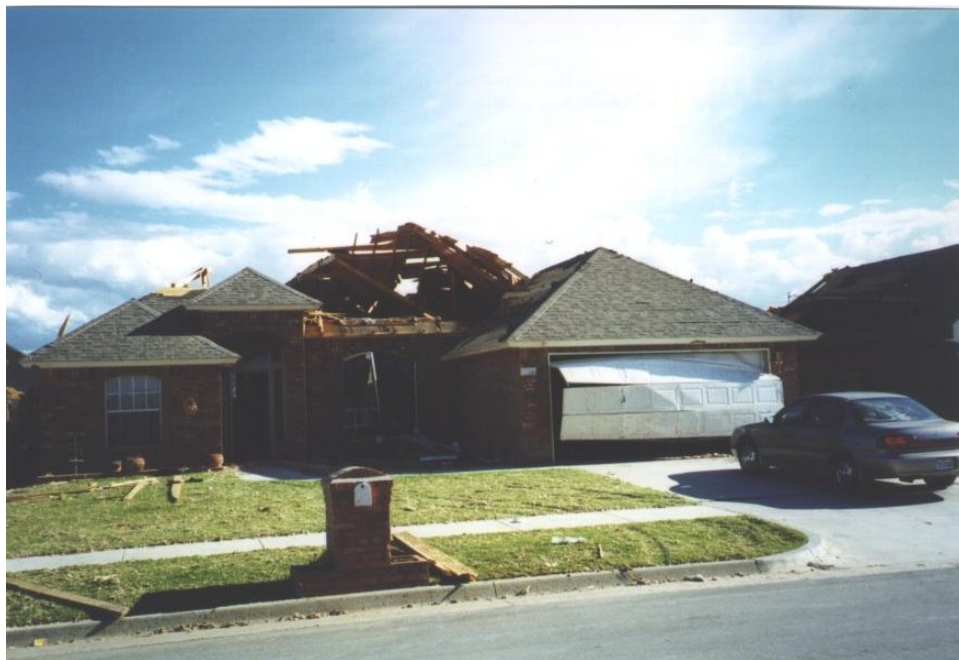
FR12: DOD 4: Uplift of roof deck and loss of roof covering (>20%); garage door collapses outward

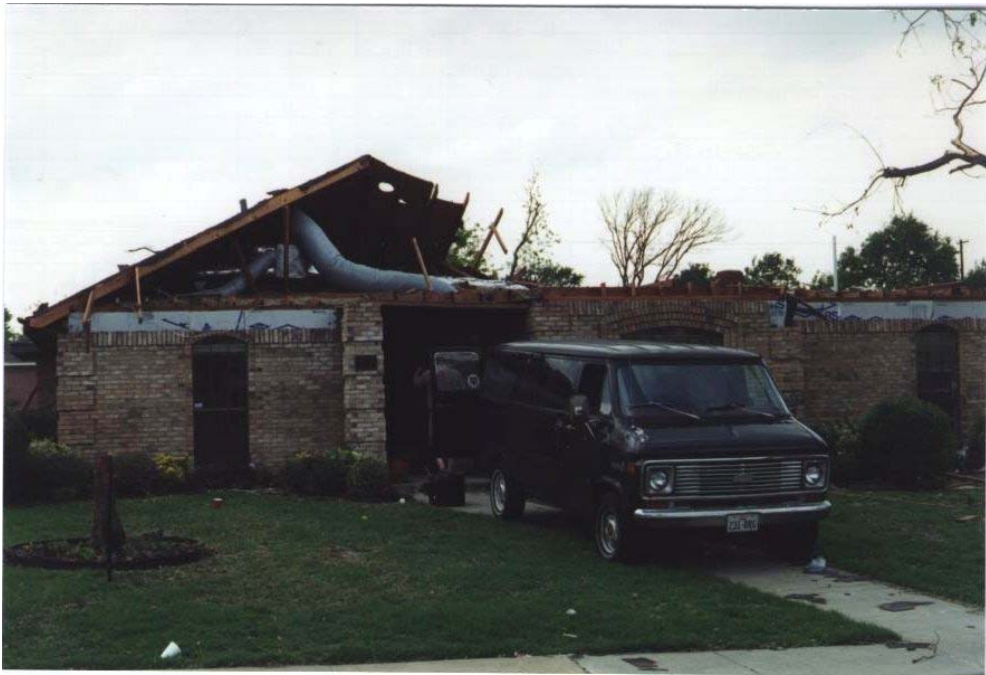
FR12: DOD 6: Large sections of roof removed; most walls remain standing

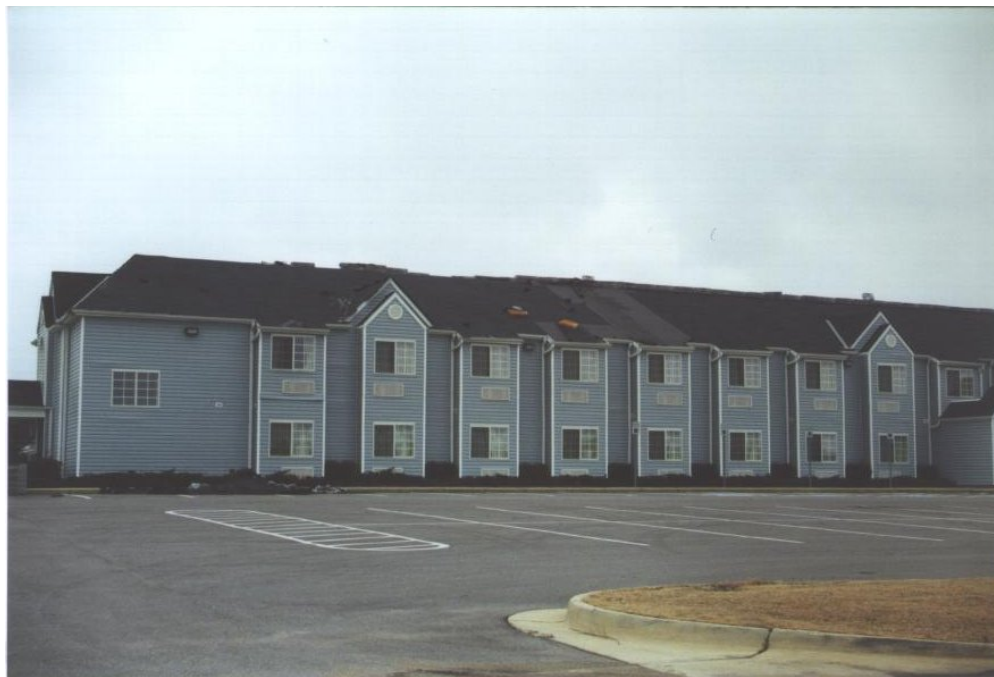
ACT: DOD 2: Loss of roof covering (<20%)

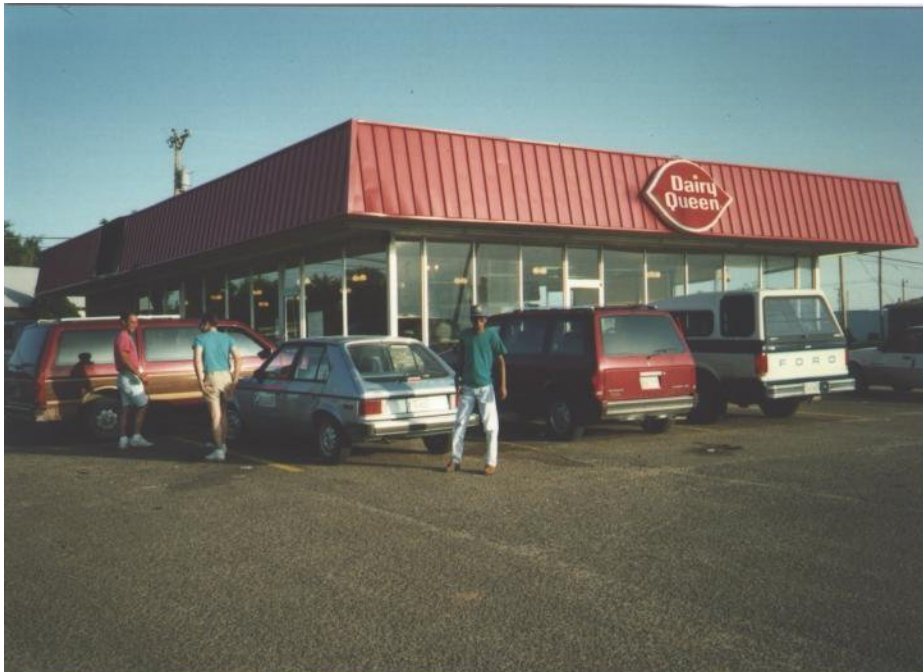
SRP: DOD 3: Broken glass in windows and doors

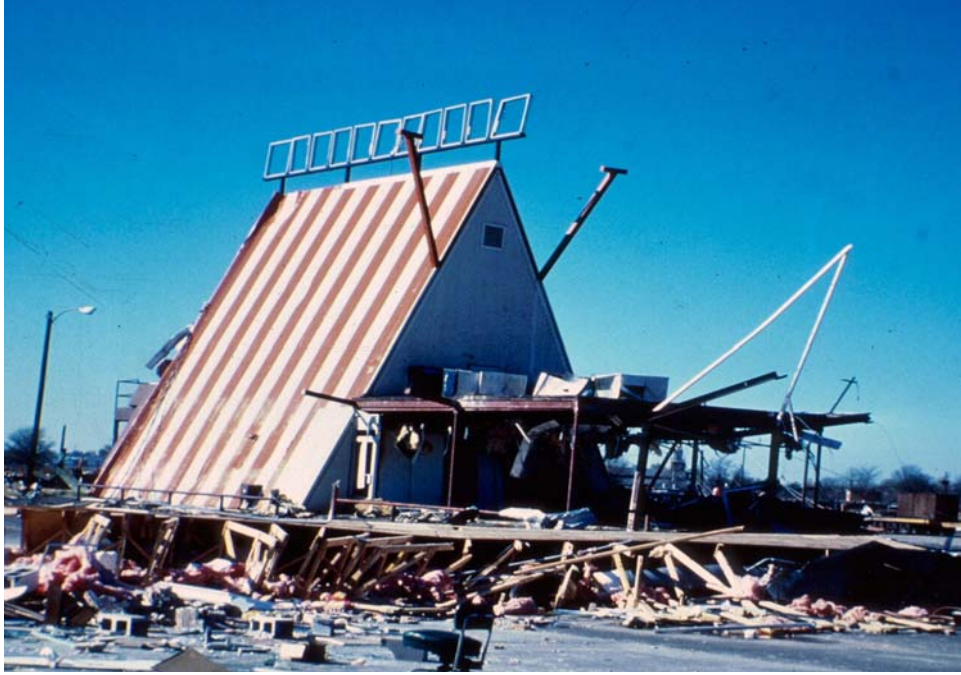
SRB: DOD 5: Canopies and covered walkways destroyed

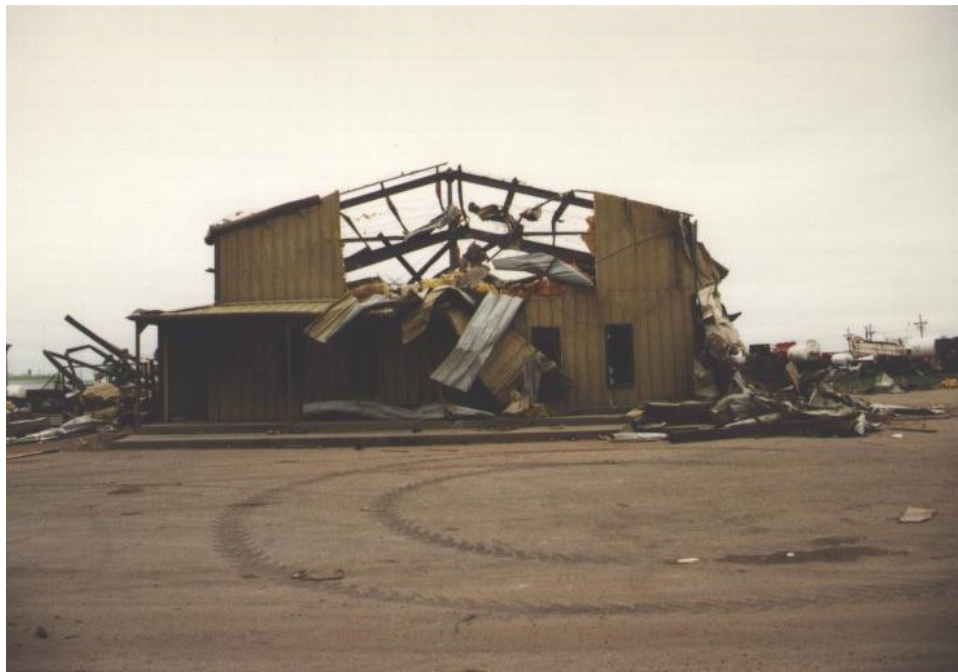
MBS: DOD 7: Collapse of rigid frames

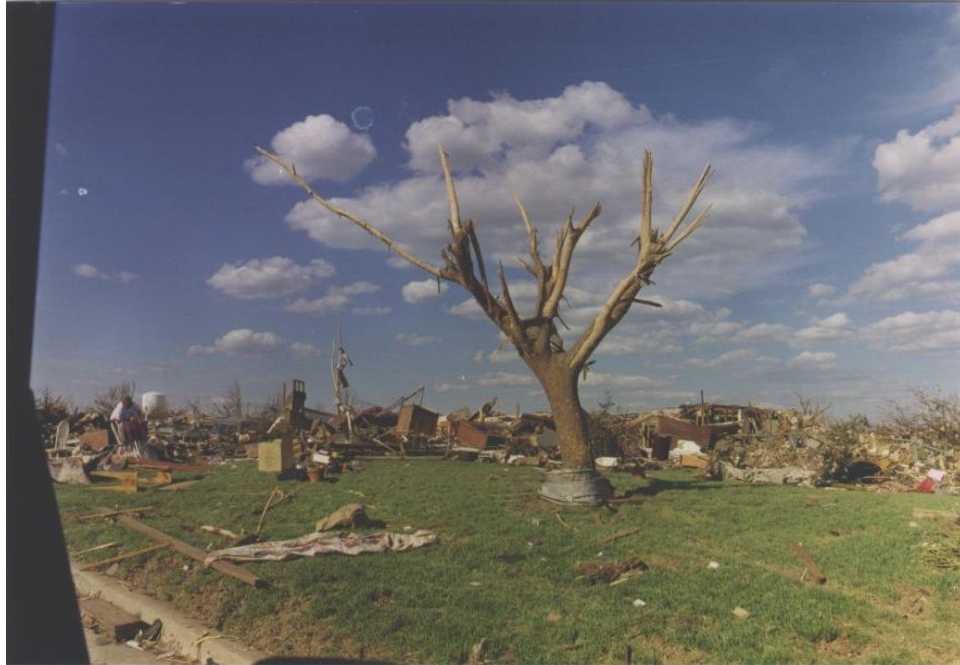
TH: DOD 5: Tree debarked with only stubs of largest branches remaining
