Diehlstadt, MO EF-2 Tornado June 4, 2012

Tornado Damage Survey - Diehlstadt, MO

...DAMAGE SURVEY RESULTS FOR DIEHLSTADT MISSOURI...

Downburst information Diehlstadt, Missouri

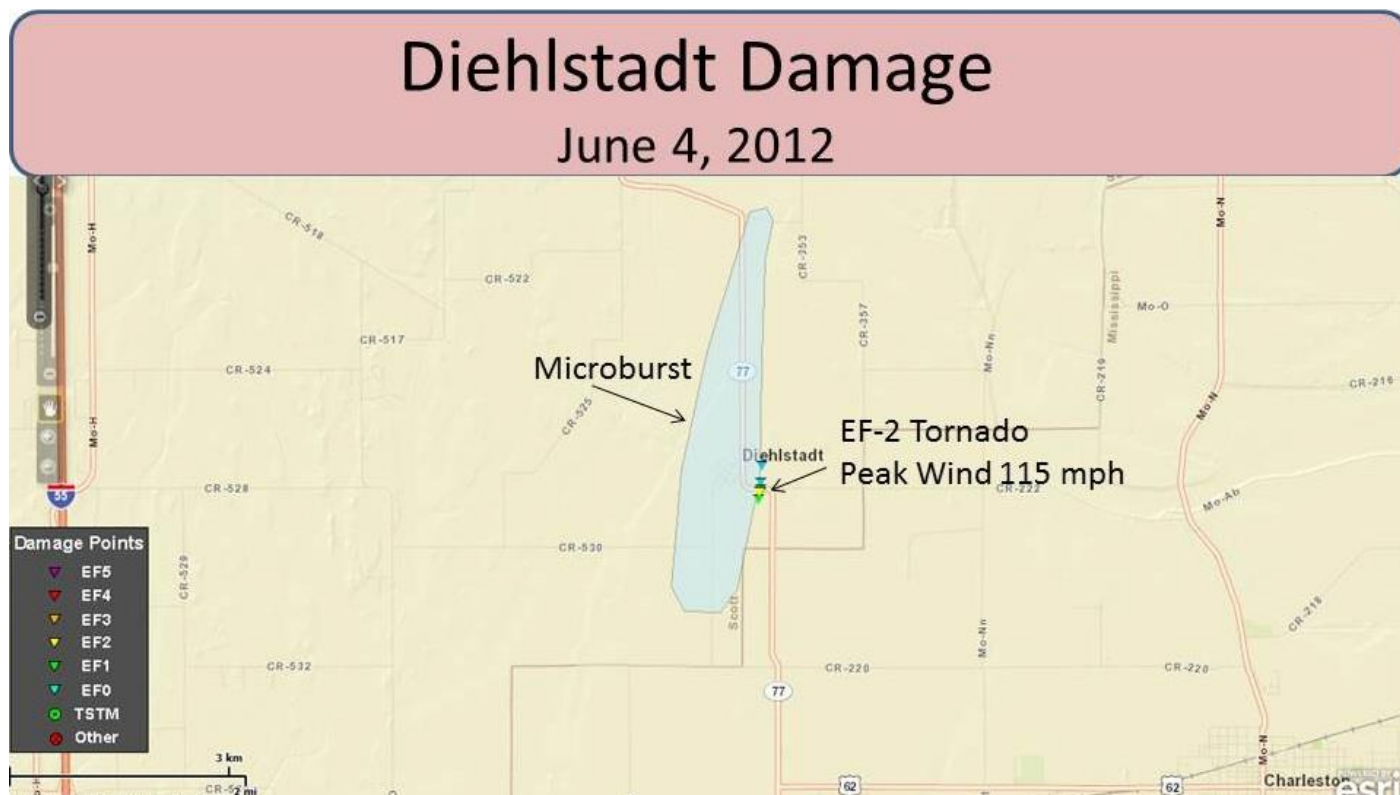
A map of the surveyed tornado and downburst is provided for reference:

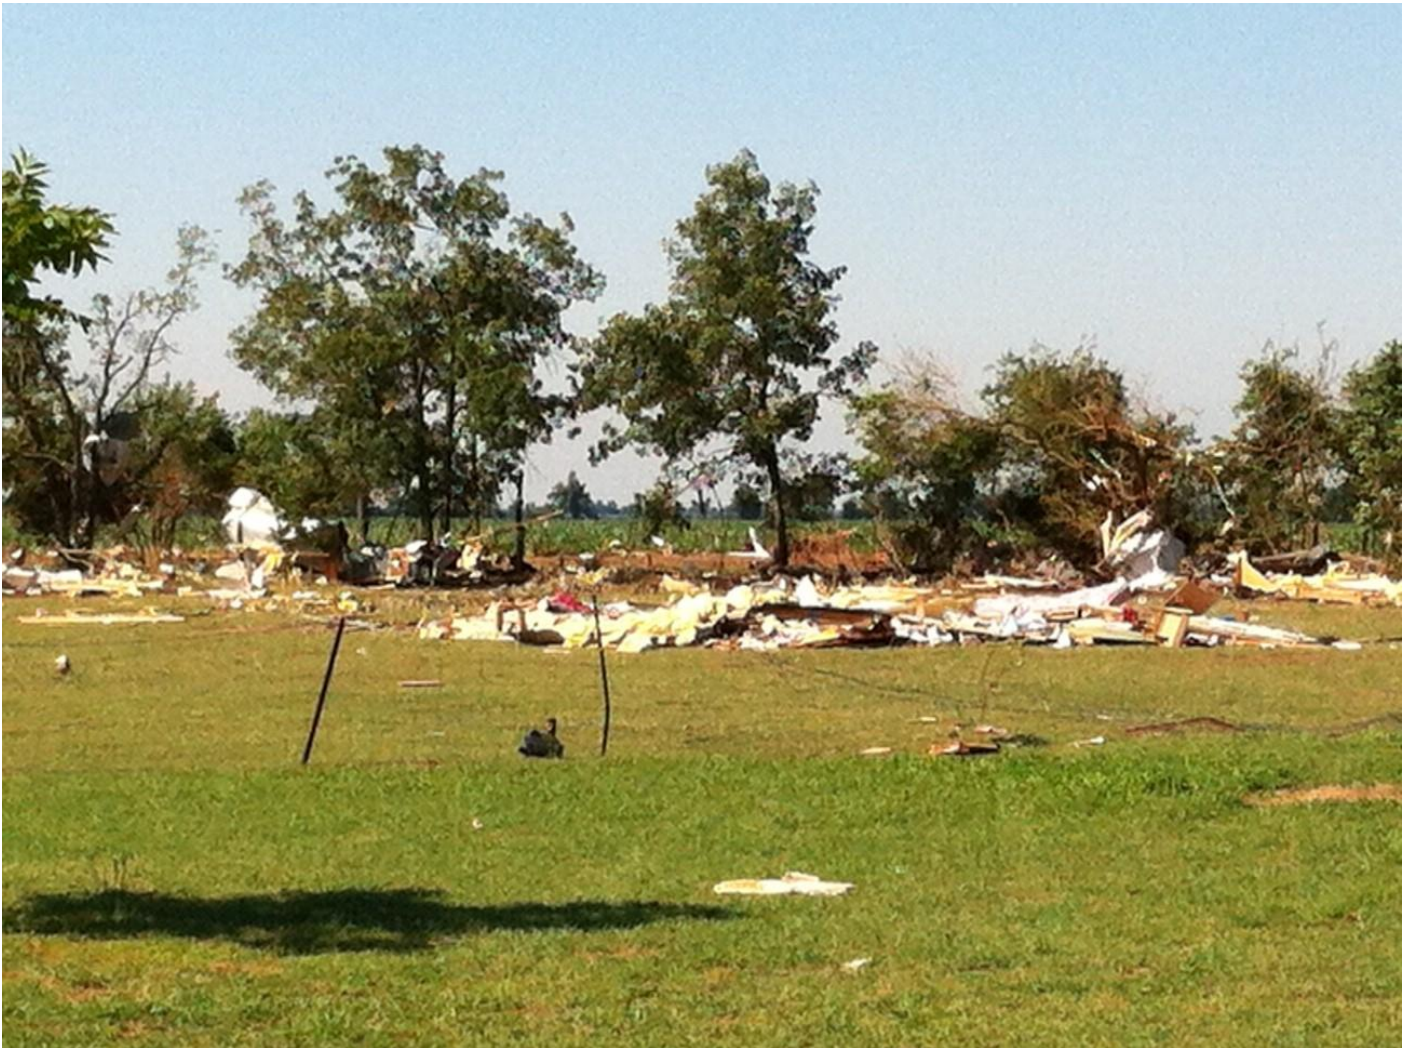
* EVENT TYPE.....EF2 TORNADO
* EVENT DATE.....MONDAY JUNE 4 2012
* EVENT TIME.....844 PM CDT
* EVENT LOCATION.....1/4 MILE NORTH OF DIEHLSTADT TO 1/4 MILE SOUTH OF DIEHLSTADT
* PEAK WIND.....115 MPH
* AVG. PATH WIDTH.....75 YARDS
* PATH LENGTH.....0.5 MILES
* INJURIES.....NONE
* FATALITIES.....3
* DAMAGE DETAIL.....A SINGLE WIDE MOBILE HOME WAS COMPLETELY DESTROYED AND SCATTERED WITH THE UNDERCARRIAGE BLOW APPROXIMATELY 100 YARDS FROM THE HOME SITE. SEVERAL LARGE

WAREHOUSE BUILDINGS WITH PARTIAL ROOF LOSS AND STRUCTURAL DAMAGE. SEVERAL TREE SNAPPED OR UPROOTED. FENCING AND SIGN BLOWN DOWN.

Image of mobile home demolished by EF-2 tornado in Diehlstadt, MO

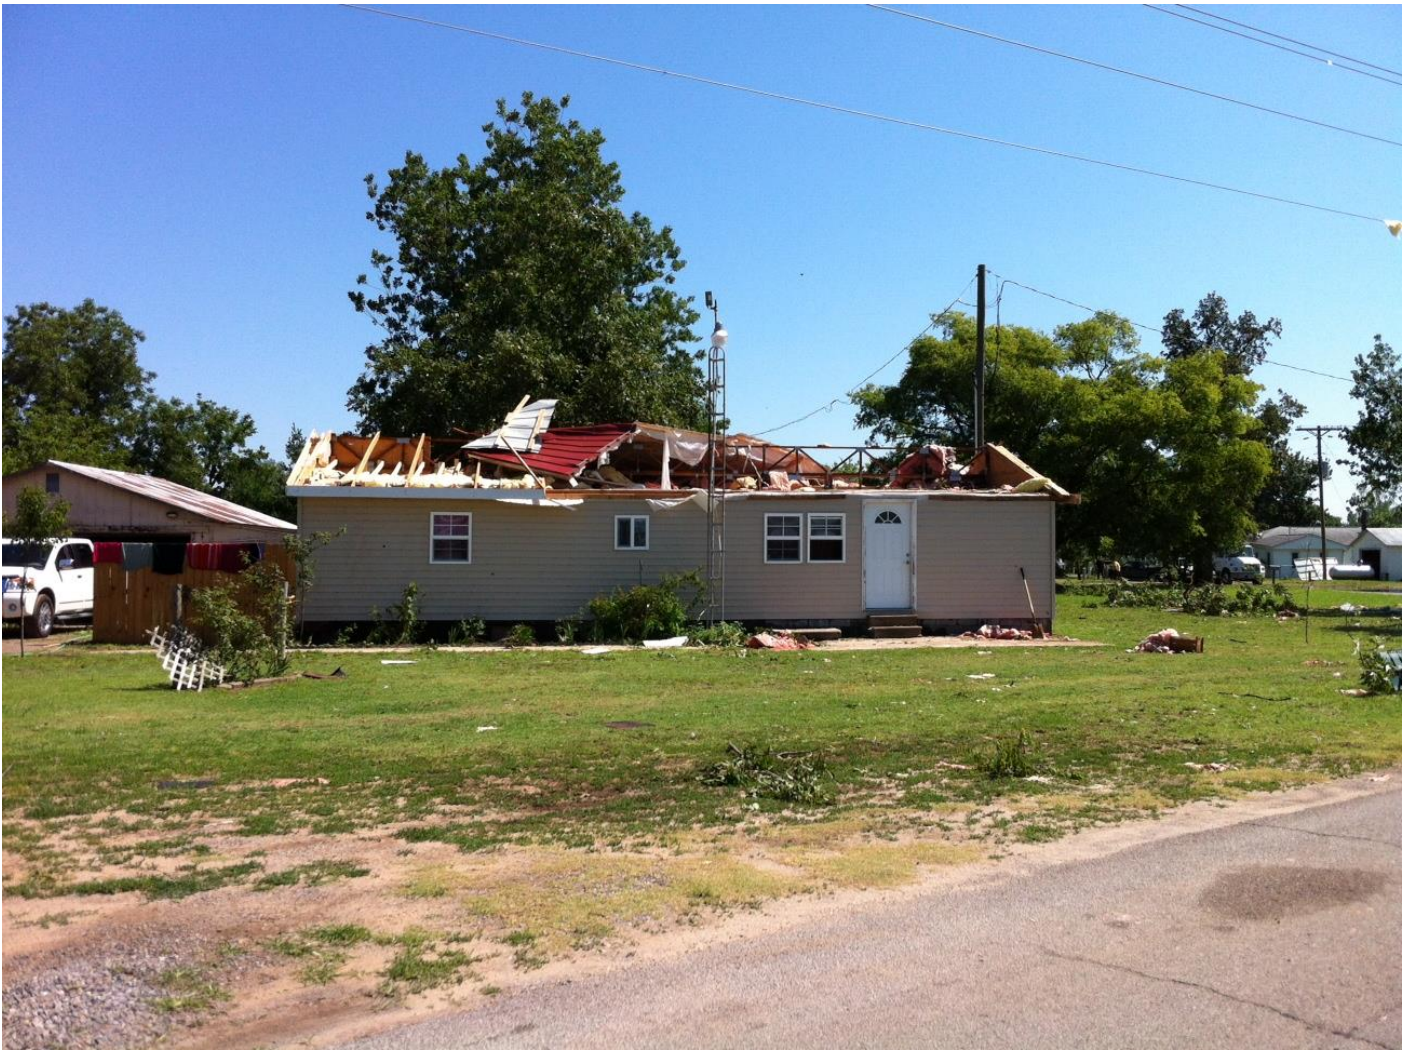
* EVENT TYPE.....DOWNBURST
* EVENT DATE.....MONDAY JUNE 4 2012
* EVENT TIME.....840 PM CDT
* EVENT LOCATION.....2.5 MILES NORTH OF DIEHLSTADT TO 1 MILE SOUTH OF DIEHLSTADT
* PEAK WIND.....100 MPH
* AVG. PATH WIDTH....1/2 MILE
* PATH LENGTH.....3.5 MILES
* INJURIES.....NONE
* FATALITIES.....NONE
* DAMAGE DETAIL.....52 HOMES DAMAGED WITH MOSTLY MINOR TO MODERATE ROOF DAMAGE. SEVERAL
BUSINESSES AND A CHURCH DAMAGED (STEEPLE BLOWN OFF). NUMEROUS OUTBUILDINGS AND OTHER
BUILDINGS DAMAGED. SEVERAL POWER POLES SNAPPED...MANY DOZENS OF TREES UPROOTED OR
SNAPPED. IRRIGATION SYSTEM WAS TOPPLED.

Image of mobile home damaged by downburst in Diehlstadt, MO
